ES&H Coordinator's Meeting

Rigging Incident
LHC Magnet
Michael Gaffney
October 18, 2001

Incident Description

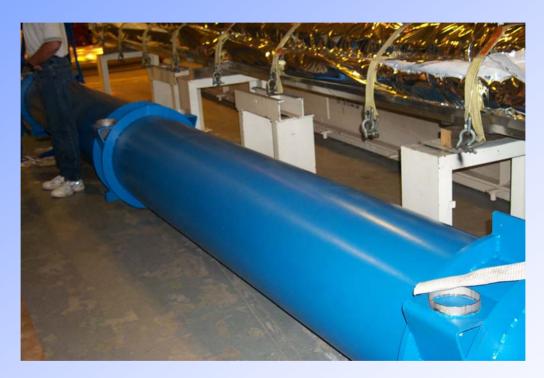
Weight ~ 11,000 lbs

■ Diameter ~ 24 in

■ Length ~ 40 ft
